Manhole Inspection Summary

Manhole # S35M1_012MH

Insp Date: **4/21/08 10:18 AM**

Location Address: **18 Reedbird Ave.**

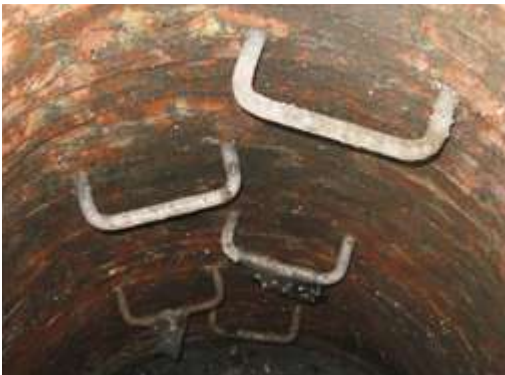
Steps Count: **5** Missing: **0** ☒ **Corroded**

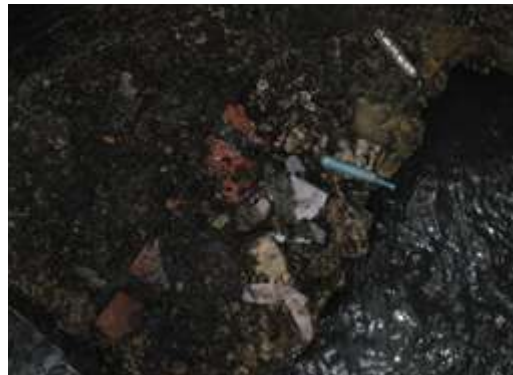
Defect 1

Trash/etc...

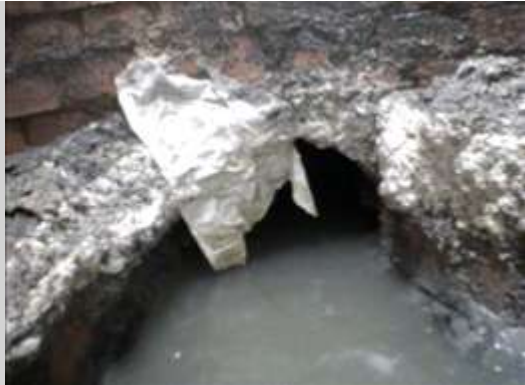
12 O'Clock Outflow

12 in. Circular Gravity Sewer
Pipe Out @ 12 O'Clock

Pipe Height: **13.2** (in.) Rod and Bar (Angled)
Pipe Material: **Clay** ☐ Pipe Lined
Invert Depth: **10.48** (ft.) Flow Characteristics: **Fast**
Deposits: ☒ None ☐ Mud ☐ Sludge ☐ Debris ☐ Grease
Silt Depth: (in.) Deposits Extent:
Infiltration: **None** Pipe Seal Cond: **Sound**

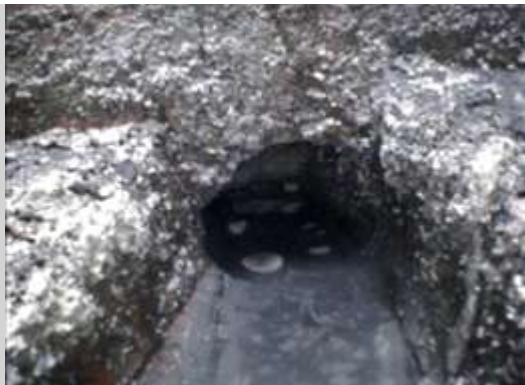
3 O'Clock Inflow

8 in. Circular Service Sewer
Pipe In @ 3 O'Clock

Pipe Height: **8.4** (in.) Rod and Bar (Angled)
Pipe Material: **Clay** ☐ Pipe Lined
Invert Depth: **10.08** (ft.) Flow Characteristics: **None**
Deposits: ☒ None ☐ Mud ☐ Sludge ☐ Debris ☐ Grease
Silt Depth: (in.) Deposits Extent:
Infiltration: **None** Pipe Seal Cond: **Sound**

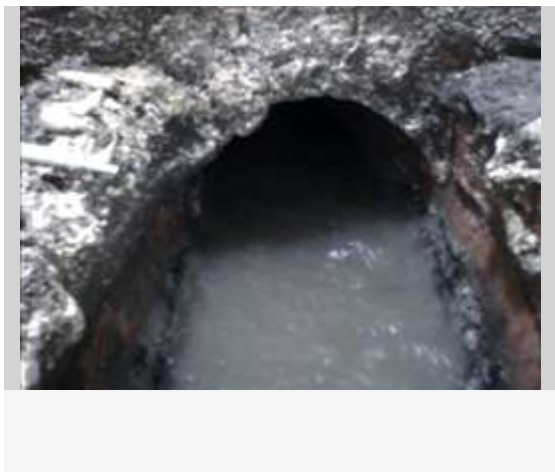
6 O'Clock Inflow

12 in. Circular Gravity Sewer
Pipe In @ 6 O'Clock

Pipe Height: **12** (in.) Rod and Bar (Angled)
Pipe Material: **Clay** ☐ Pipe Lined
Invert Depth: **10.32** (ft.) Flow Characteristics: **Fast**
Deposits: ☒ None ☐ Mud ☐ Sludge ☐ Debris ☐ Grease
Silt Depth: (in.) Deposits Extent:
Infiltration: **None** Pipe Seal Cond: **Sound**
